**DEPARTMENT OF TRANSPORTATION****DIVISION OF ENGINEERING SERVICES**

Tower Shop Bay 3 Deck Panel repairs

# WELDING INSPECTION REPORT

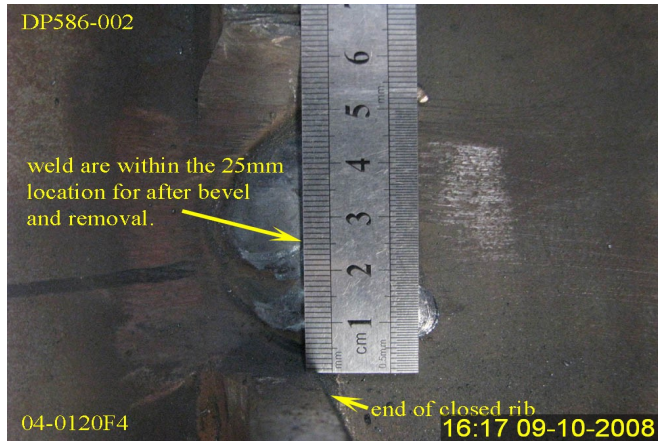
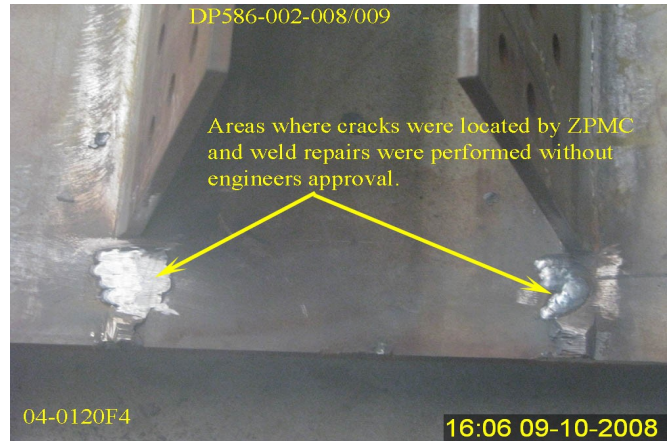
The QA Inspector randomly observed ZPMC personnel performing grinding of repairs for the Orthotropic Box Girder (OBG) deck panel Partial Joint Penetration (PJP) welds. During initial observations it was noted that fourteen (14 ea) deck panels are inside the shop. This QA inspector was informed by ZPMC MT technician that during his MT inspection on deck panel DP586-002 and had found cracks in the base metal at the ends of welds 008/009. This QA inspector observed ZPMC repair these welds without engineer's approval and no documentation of welding parameters. ZPMC QC Fu Yu Hong was informed that an incident report [TL-15] will be issued for this occurrence. This QA inspector while continuing his observation noted that ZPMC was continuing to perform deck panel weld repairs without documenting the welding parameters on DP567-001. ZPMC QC Fu Yu Hong was informed that an incident report will be issued for this occurrence also. A 3 party final visual inspection was conducted by ZPMC, ABF and Caltrans QA inspector for deck panel DP567-001 after all 3 parties had agreed the repairs appeared to be within compliance at the time of VT the ABF tracking tag was signed by all parties involved. Deck panel DP586-002 was requested for final VT by ZPMC and it was relayed to ABF Kevin Chen that CT would participate with the VT but due to a pending TL-15 could not sign the panel as within compliance at this time. ABF Kevin Chen proceeded with his final VT of the deck panel and discovered multiple locations on the first weld that was not in compliance. Mr. Chen then spoke with ZPMC and informed them that ZPMC needed to go back through the repair areas again that this panel was not ready for a final visual inspection by ABF or CT. Certified Welding Inspector for ZPMC Li Yan Hua was present at this location along with QC Fu Yu Hong and told this QA inspector that they would go back through the deck panel to insure it was ready for final VT at a later time.
